**Home Inspection Report**

123 Inspectionville Street  
Austin, TX, 78754

## PROPERTY INSPECTION REPORT

**Concerning: 123 Inspectionville Street Austin, TX, 78754**

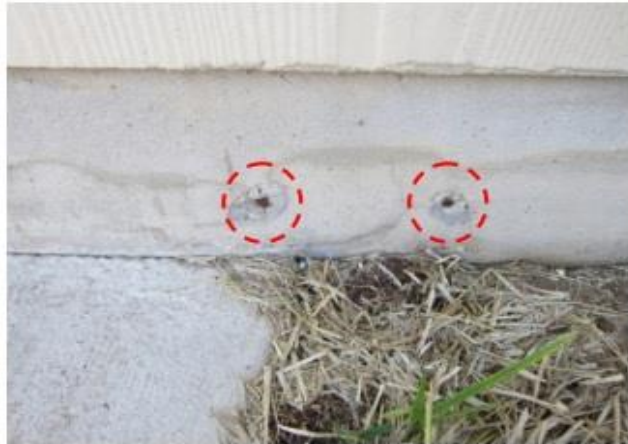
### A. Foundations

Comments: Foundation appeared to be performing as intended.

This inspector is required to report any exposed iron as a deficiency.

DEF: Exposed iron should be sealed to prevent rusting, which can have adverse effects upon the foundation.

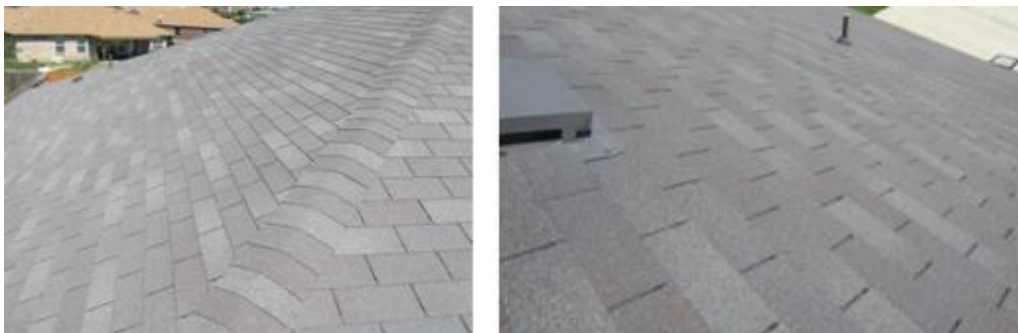
### C. Roof Covering Materials

Types of Roof Covering: 3-tab asphalt shingles

Viewed from: climbing atop rooftop and from ground level using binoculars

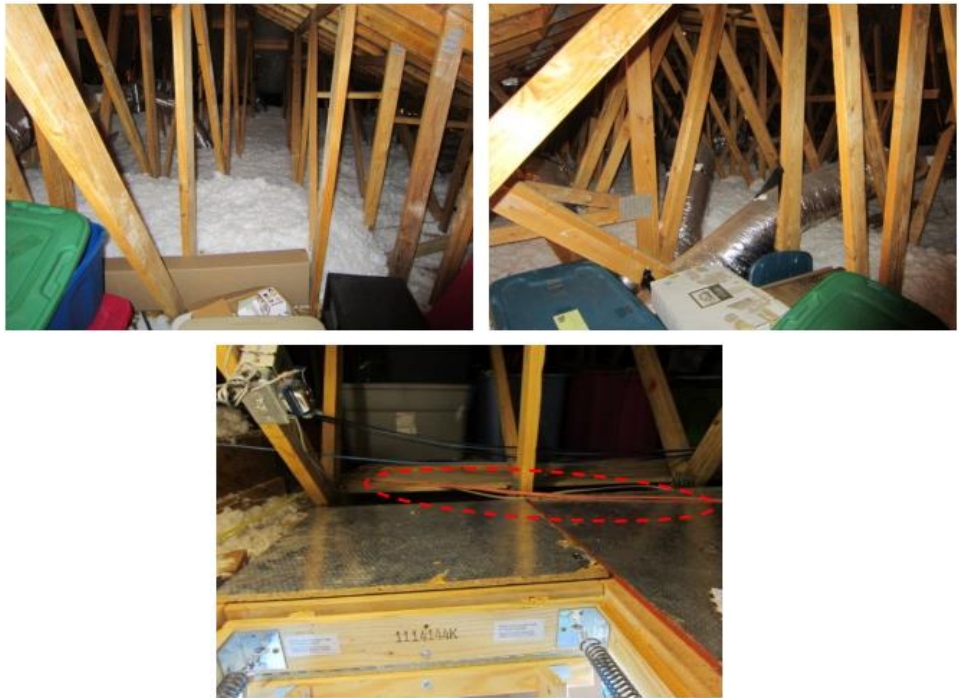
**D. Roof Structures and Attics**

*Viewed from: entering attic via pulldown stairway in the garage ceiling*  
*Attic structure type: engineered web-truss design; radiant barrier roof decking*

*Approximate Average Depth of Insulation: 12 inches*  
*Comments: Stored items and insulation covering ceiling rafters limited this inspector's access to all areas of the attic. Attic insulation and ventilation appeared to be adequate.*

CAUTION: For your safety, electrical wiring near attic access should be protected

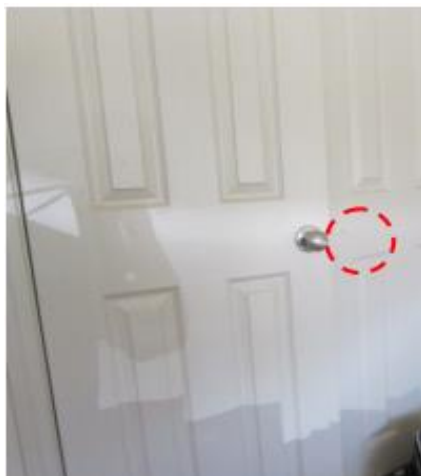
**G. Doors (Interior and Exterior)**

*Comments: Closet doorknob missing*

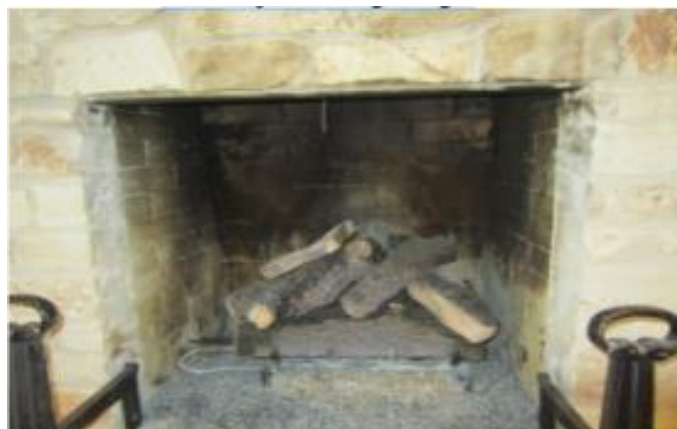
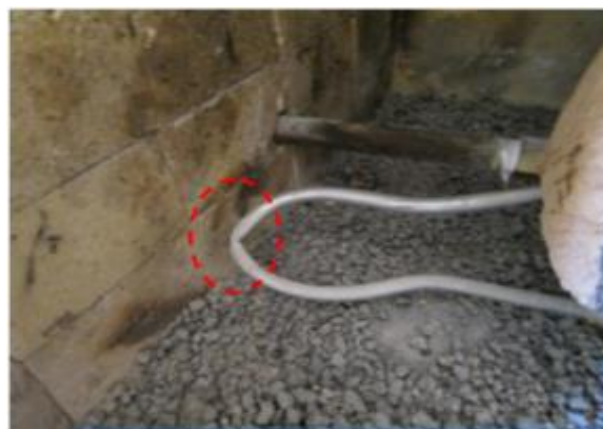
**J. Fireplaces and Chimneys**

*Comments: Gas fireplace has gas logs. Damaged/kinked gas line in fireplace should be replaced.*

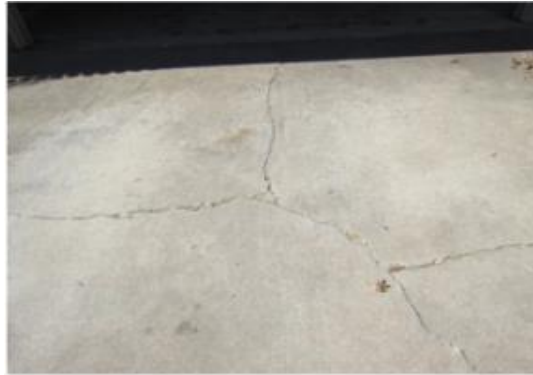
### K. Porches, Balconies, Decks and Carports

*Comments: Cracks in driveway and in garage floor are common cosmetic concerns.*

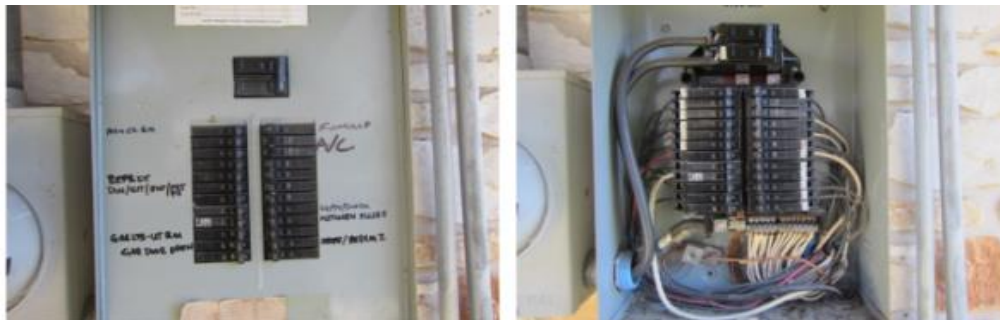
### A. Service Entrance and Panels

*Comments: Main Service Panel and 100 Amp Main Disconnect is located near the left rear corner of the home. A smaller subpanel is located beneath the Main Service Panel.*

*For reasons cited in Sections II. A. and II. B. (Electrical Systems), it is recommended to have the home's electrical systems evaluated by a licensed electrician.*

*Contact the electric utility provider to ask if it is within their jurisdiction to trim tree limbs away from overhead service cables.*

*DEF: All breakers should be clearly and permanently labeled.*

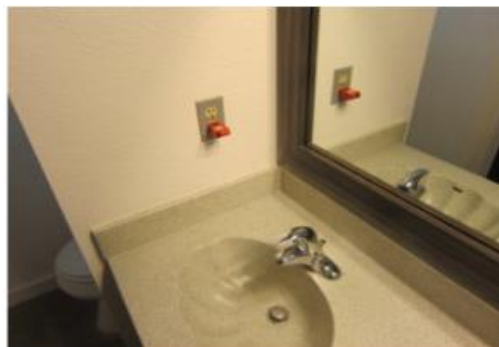
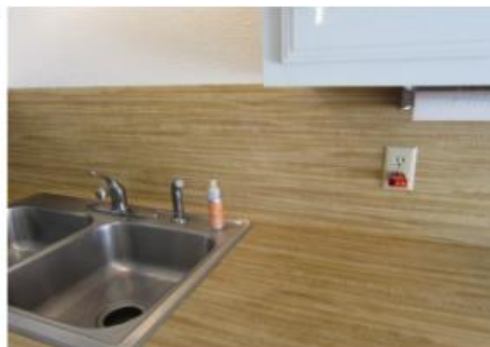
**B. Branch Circuits, Connected Devices and Fixtures**

DEF: Ground-Fault-Circuit-Interrupter (GFCI) protection was NOT present anywhere in the home. For your safety, GFCI protection should be present for receptacles in locations such as: all kitchen countertops; bathrooms; within 6 feet of sinks (living room, laundry/utility).

For reasons cited in Sections II. A. and II. B. (Electrical Systems), it is recommended to have the home's electrical systems evaluated by a licensed electrician.

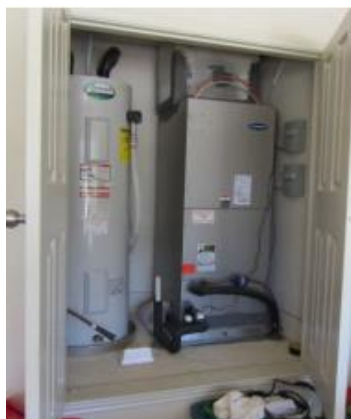
**A. Heating Equipment**

Type of Systems and Energy Sources: Home is equipped with an electric Central air heating system.

Comments: Furnace and air handling unit is located in a garage closet. Heating system appeared to be functioning as intended.

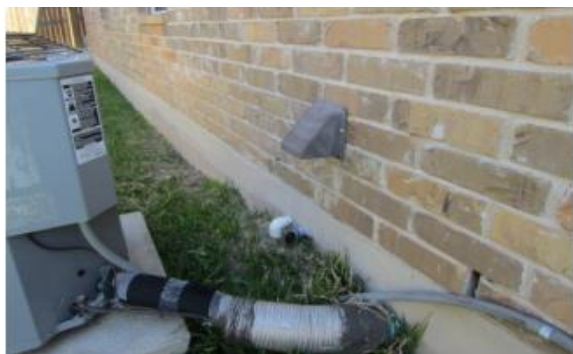
**B. Cooling Equipment**

Comments: Exterior condenser/compressor unit is located on the left side of the home.

Interior evaporator/air handling unit is located in a garage closet

Return air temp: 70.3F ; Conditioned air temp: 48.1F ; Temp DIFFERENTIAL = 22.2 F

This temperature differential (measured across the evaporator coil) is within the expected/acceptable range. Cooling system appeared to be functioning as intended.

Termination of the primary condensate drain line was not verified

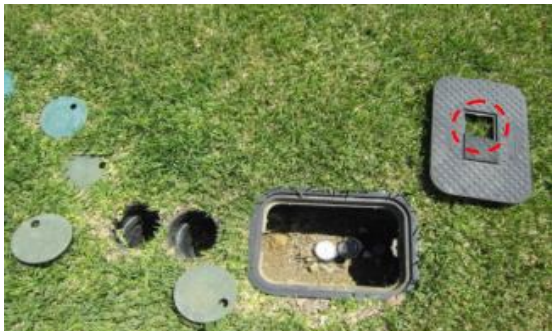
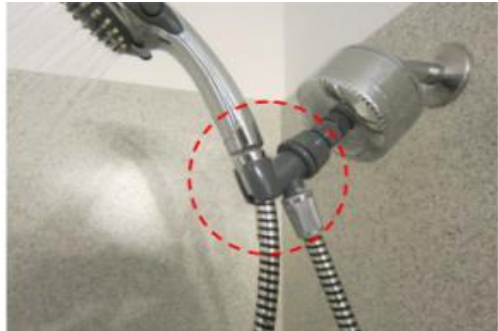
**A. Plumbing Supply, Distribution Systems and Fixtures**

Location of Water Meter: near driveway, right front corner of property Location of main water supply valve(s): near water meter

Static water pressure reading: 45 psi This is within the acceptable range of 40 – 80 psi.

Comments: DEF: Broken water meter cover in need of repair  
leak at master bathroom shower head

DEF: Slight

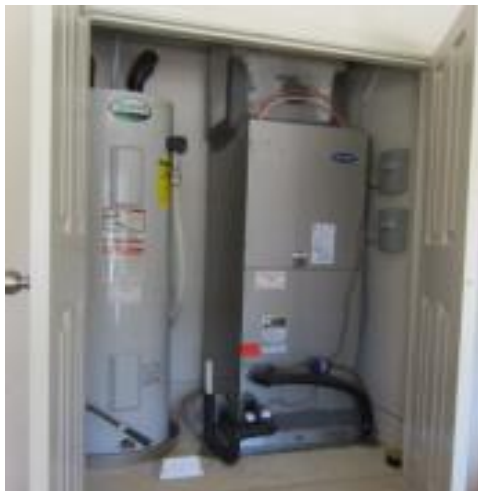
**C. Water Heating Equipment**

*Energy sources: Home is equipped with electric water heater located in a garage closet.*

*Capacity: 55-gallon*

*Comments: Water heater is functioning as intended.*

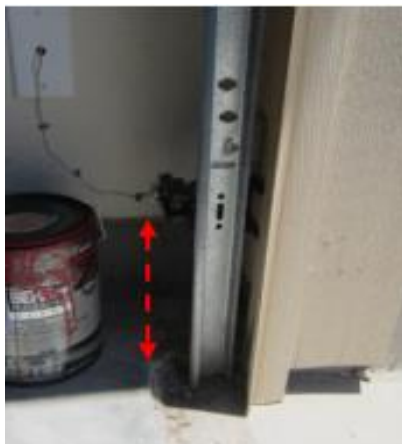
**G. Garage Door Operators**

*Comments: Overhead, electric door opener was generally functioning as intended.  
However, some attention is needed.  
DEF: For safety, floor sensors should be positioned no more than 6 inches above the garage floor.*

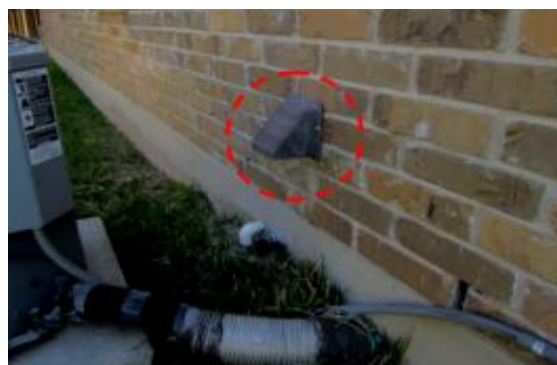
**H. Dryer Exhaust Systems**

*Comments: Clothes dryer vents to left side of the home, near the exterior A/C unit. A/C condenser fins should be monitored for unwanted lint collection.*

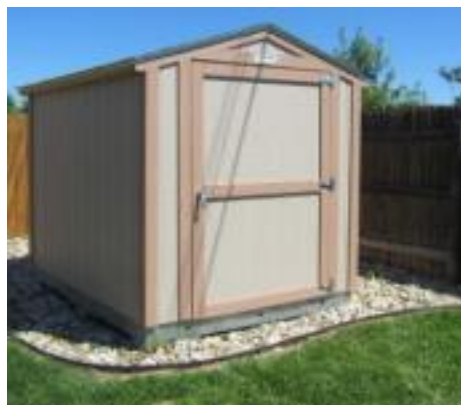
**C. Outbuildings**

Comments: A brief look inside the storage building did not reveal any electric service.
